# Lufthansa Systems FlightNav

## ***General Navigation Data Information***

**Issue 1/2015**

### **Potentially wrong turn during SID and missed approach: all Honeywell FMS types**

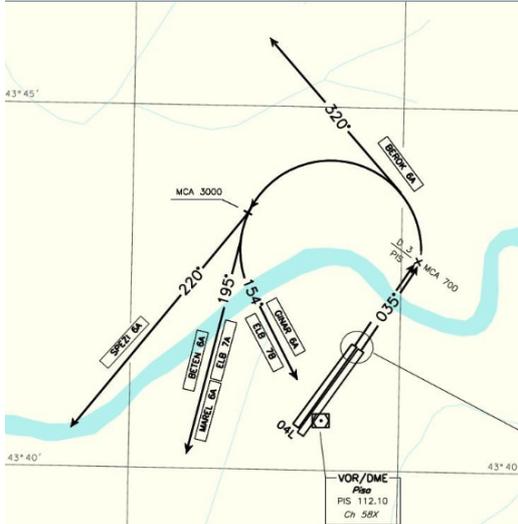
AIP page (initial climb)

See below an example of a potentially affected procedure. In this example, the erroneous turn may be seen on ground whereas on other procedures it may only be seen after takeoff i.e. after the prediction updates.
